**Iron Canyon and Bear Hole Fish Passage Project
on
Big Chico Creek**

**Preliminary Engineering
Technical Report**

April 2002

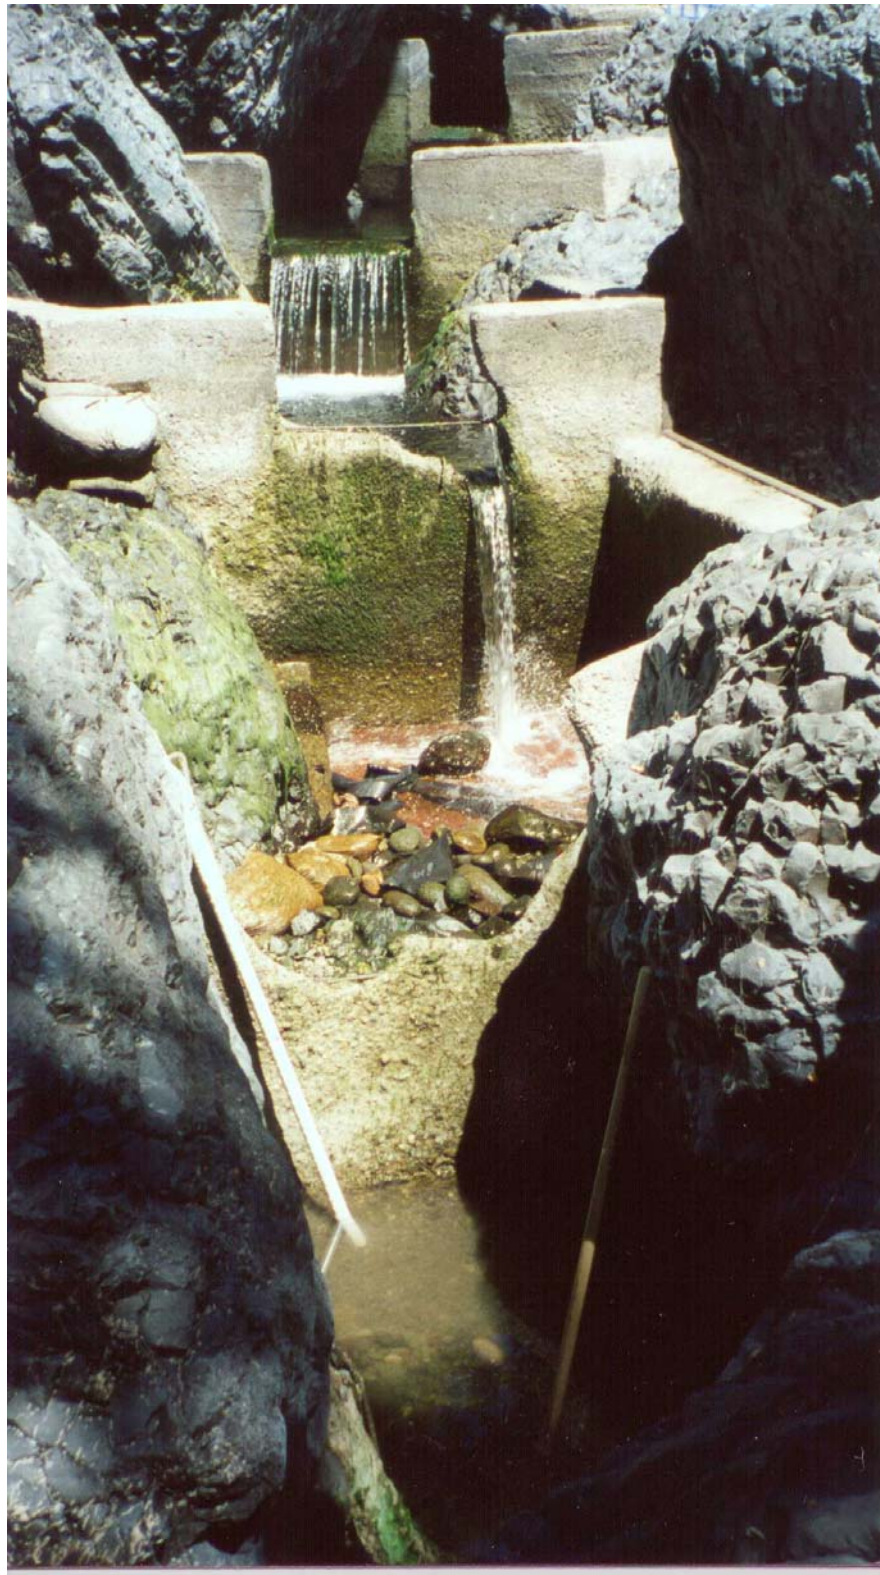
Use steel or other material to cap at least the three most badly damaged weir crests - These are weirs 2, 3, and 4. Figure 4 shows weirs 3 (foreground), 4, 5, and 6. The caps could be manufactured so they would fit over the top of the existing weirs and be bolted in place. A sealant could then be used around the edges of the cap to make a seal between the steel and concrete. The new weir caps would be set at the proper elevations to minimize the drops between pools. Slots for flashboards should be incorporated into the caps where appropriate.

Figure 4. Damaged lower fish ladder sections.

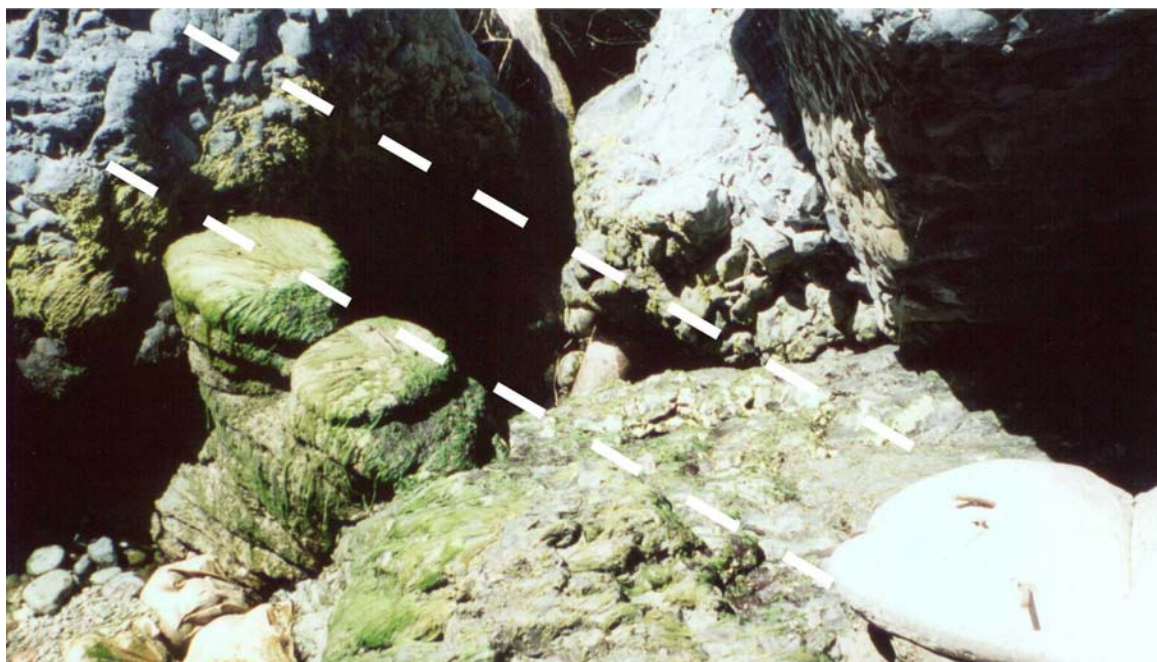
Replace two "blown-out" fish ladder walls - These are the right-side walls of Pools 3 and 4. The walls of Pools 3 and 4 are shown in Figures 5 and 6, respectively. It is unlikely these walls can be repaired due to extensive damage, so they should be replaced. Both walls are made up of concrete sandbags and poured concrete. The wall of Pool 3 was partially removed by DFG personnel as remediation for a problem that occurred downstream in the ladder. The wall of Pool 4 appears to have failed naturally over time.

Figure 5. Right bank side of Pool 3 fish ladder wall. This wall once extended across the gap indicated by the dashed lines.

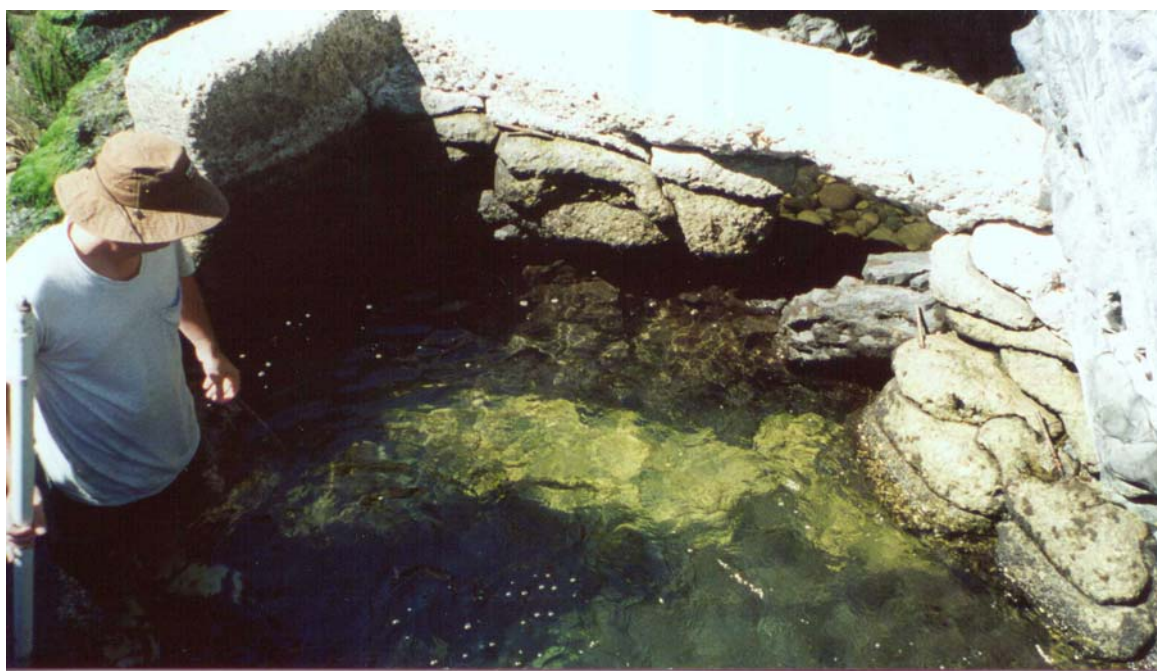
Figure 6. Right bank side of Pool 4 fish ladder wall.

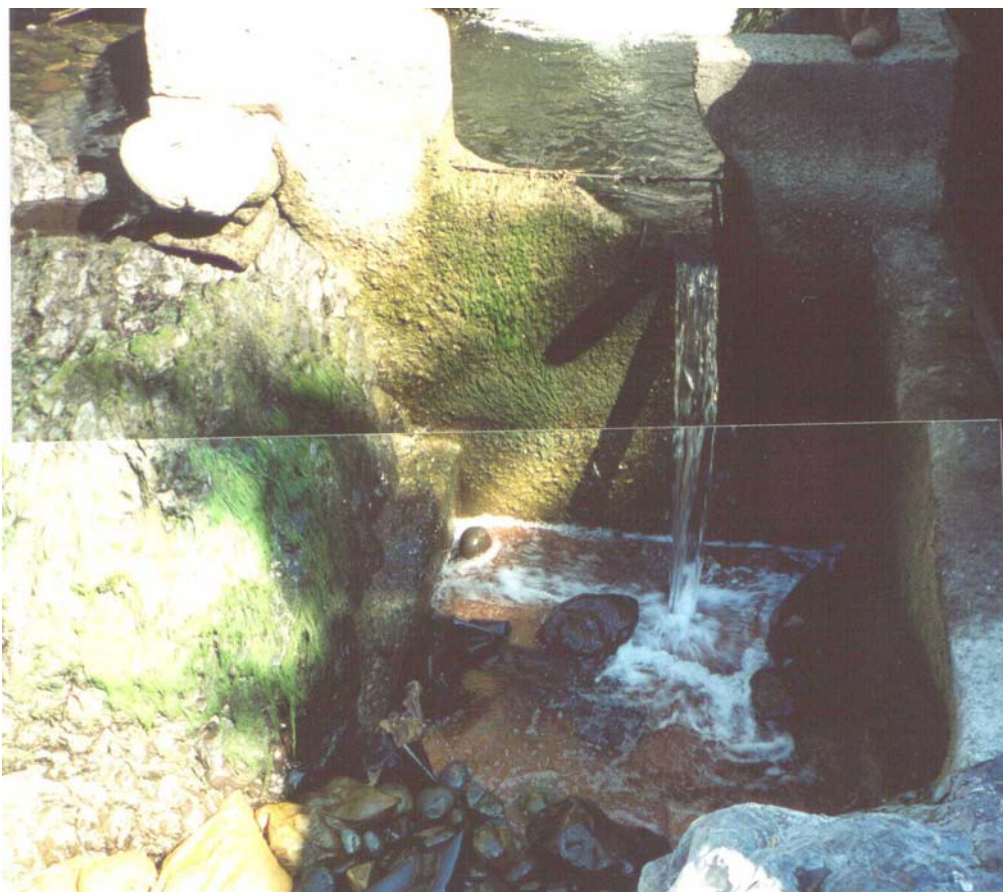
Figure 7. Floor of Pool 3 with water flowing over Weir 4.

Repair the floor of Pool 3 - It appears that the floor of Pool 3 was constructed as a bridge over a portion of the creek channel. This may have been important because the fish ladder crosses the creek channel, and bridging the channel would allow a portion of the creek flow to pass under the fish ladder instead of overtopping the walls. Presently, the floor is concrete, but has a large hole in it. This hole is covered with a sheet of plywood. Figure 7, above, shows the plywood floor, and Figure 8, on the following page, shows water flowing under the fish ladder. If the plywood is not in place, it is possible at lower flows for all of the water in the ladder to pass through the floor of this pool and not over the downstream weirs.

The underflow channel is a desirable feature that should be maintained. Repair of the damage should consist of a new concrete or steel plate floor. A steel plate floor may be easier to install than concrete, and the steel plate could be laid on top of the existing floor if it is determined that it is structurally sound. A sealant would then be used around the steel to create a watertight bond between the new steel floor and the existing concrete. Another advantage of using steel is that it could be removed for maintenance if the flow path under the ladder became clogged.

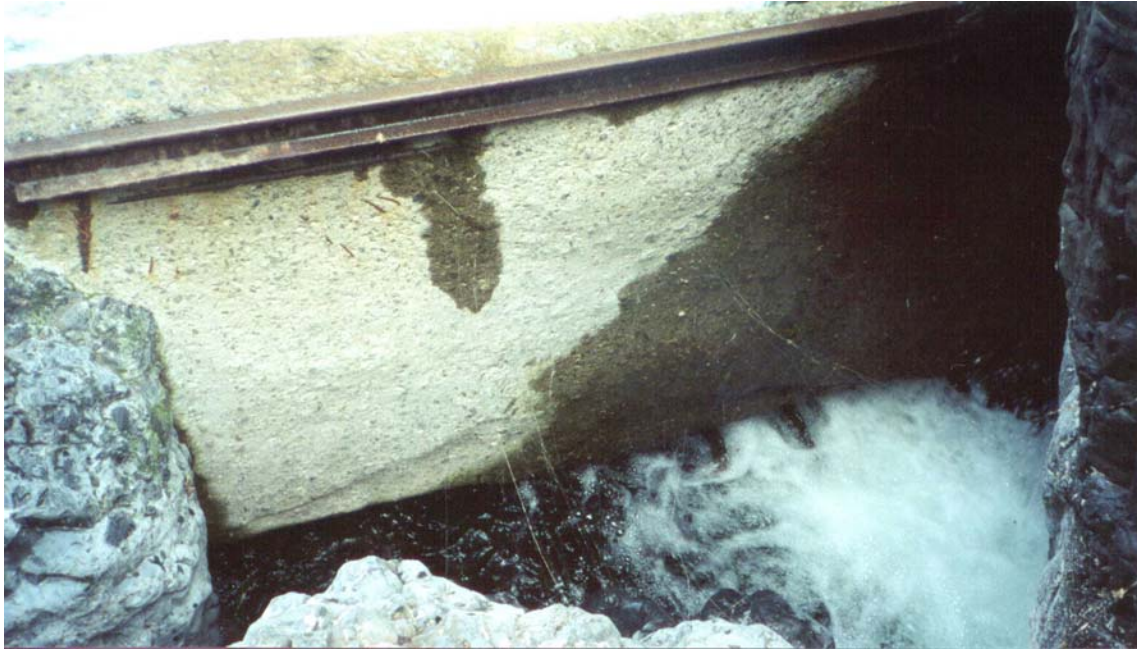
Figure 8. Water flowing under the left bank side of Pool 3.

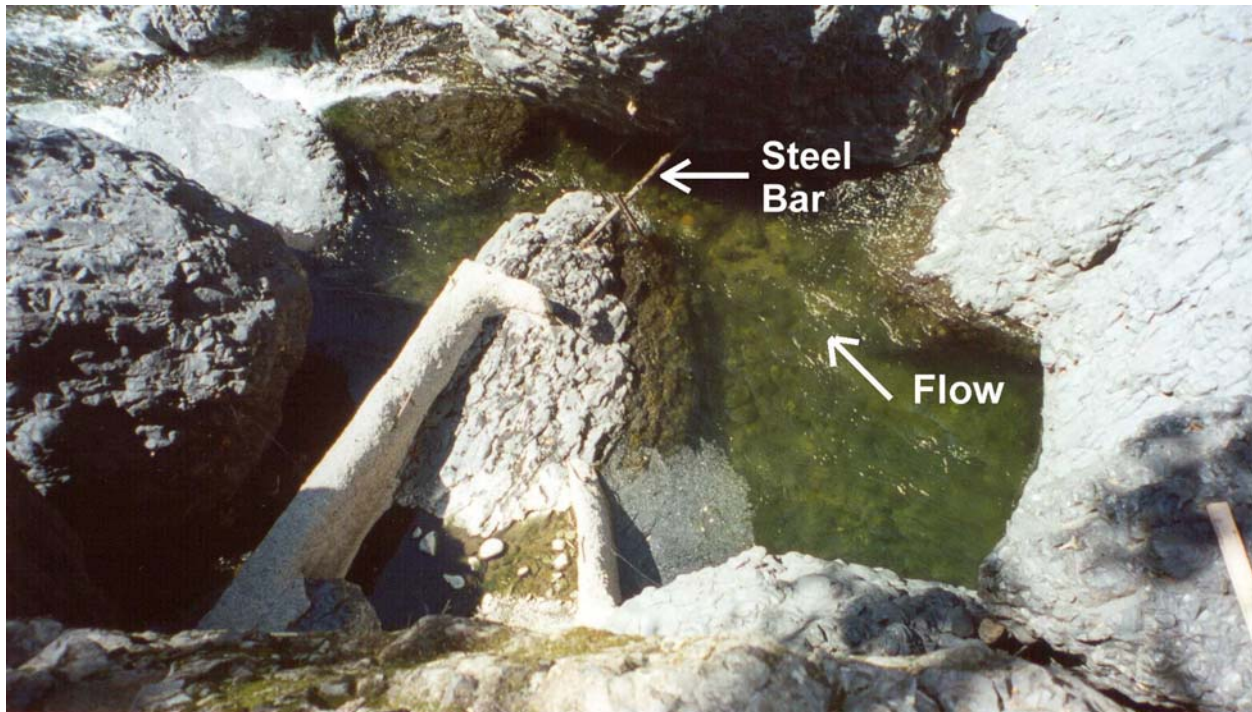
Figure 9. Pool 1, Weir 1, and steel bar (24 cfs).

It is recommended that the third option of building a concrete or steel weir in the same location is the best fix if the site can be completely dewatered.

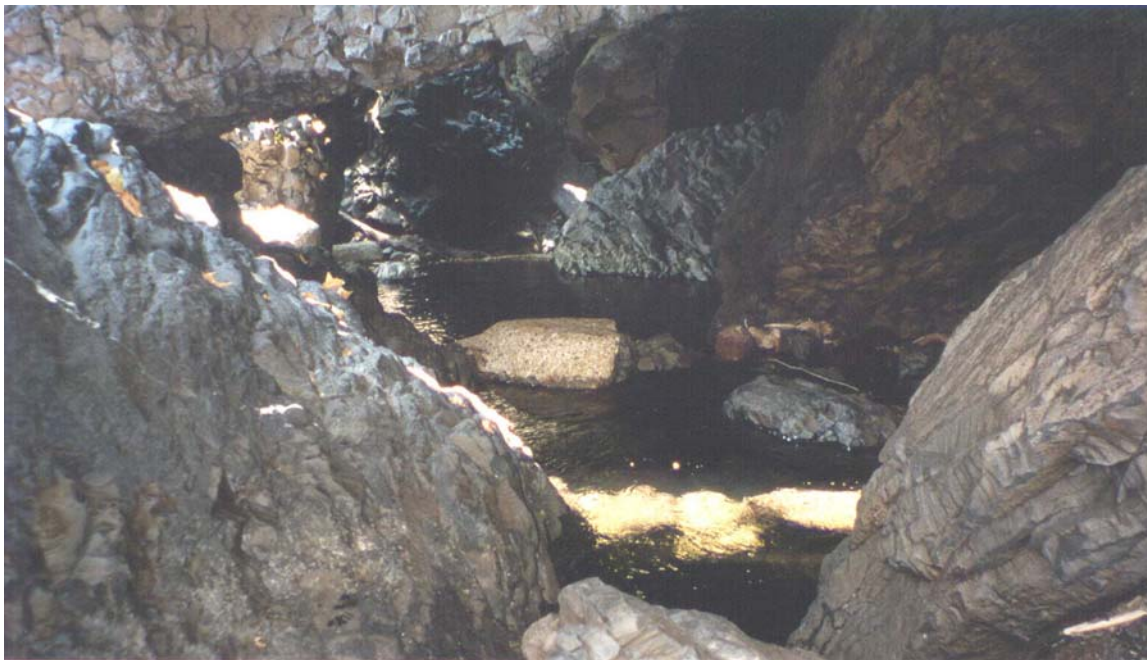
Figure 10. Weir 16 (looking downstream).

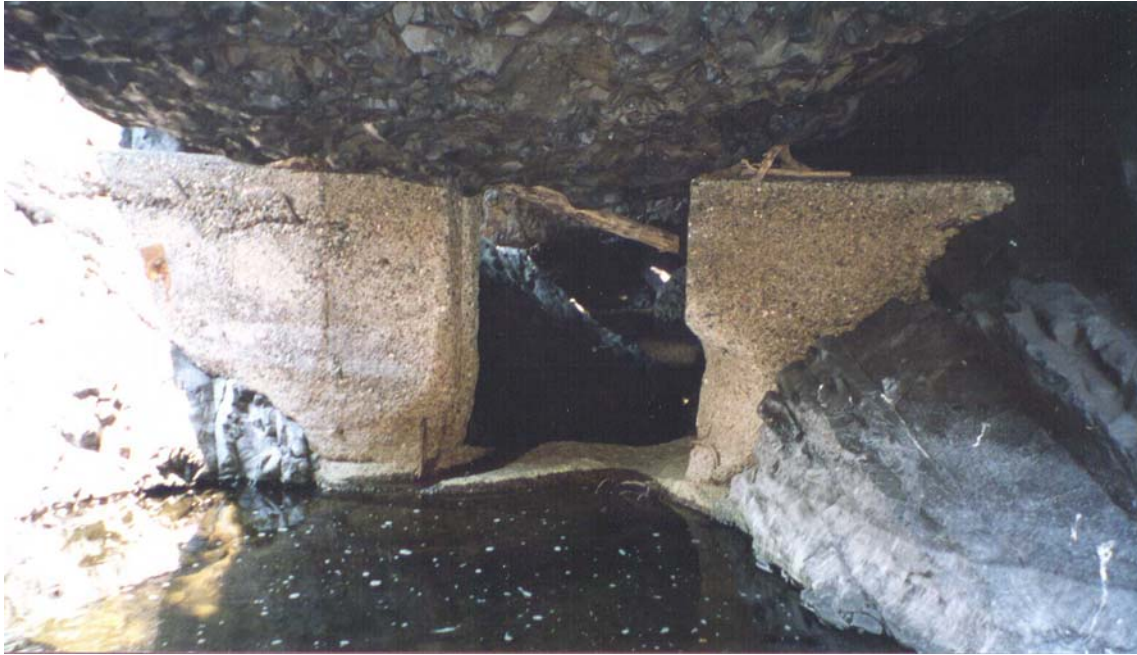
Figure 11. Fish ladder exit weir. (27 cfs)

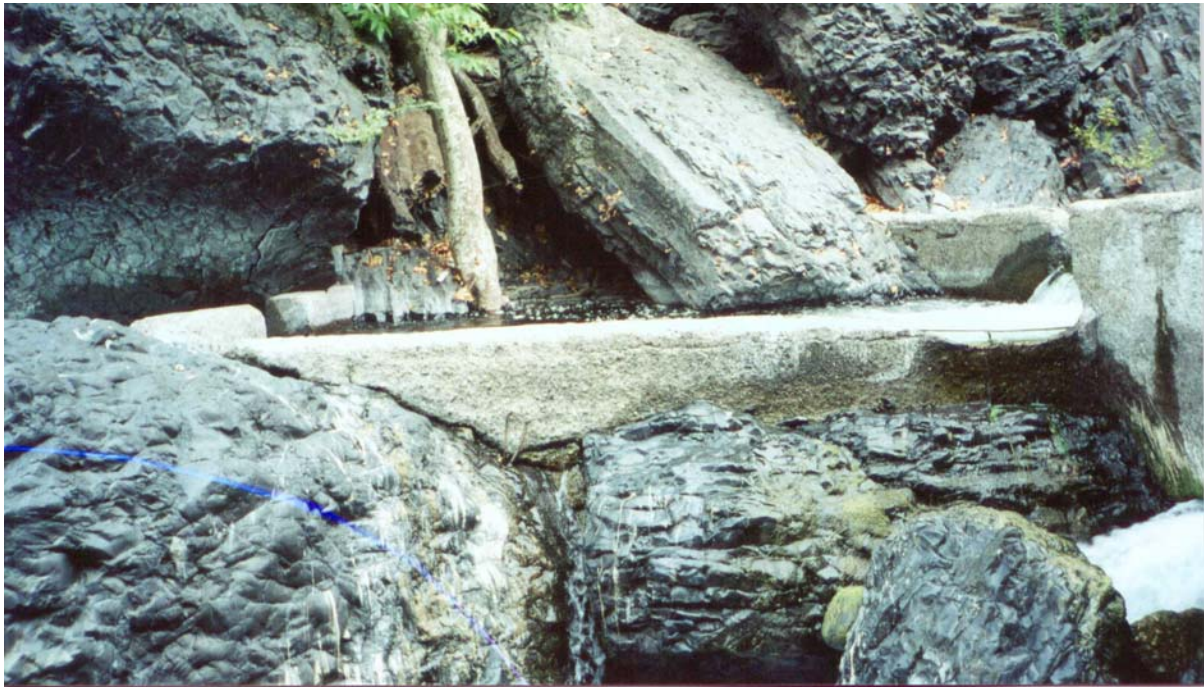
Figure 13. Left wall of Pool 6 (24 cfs).

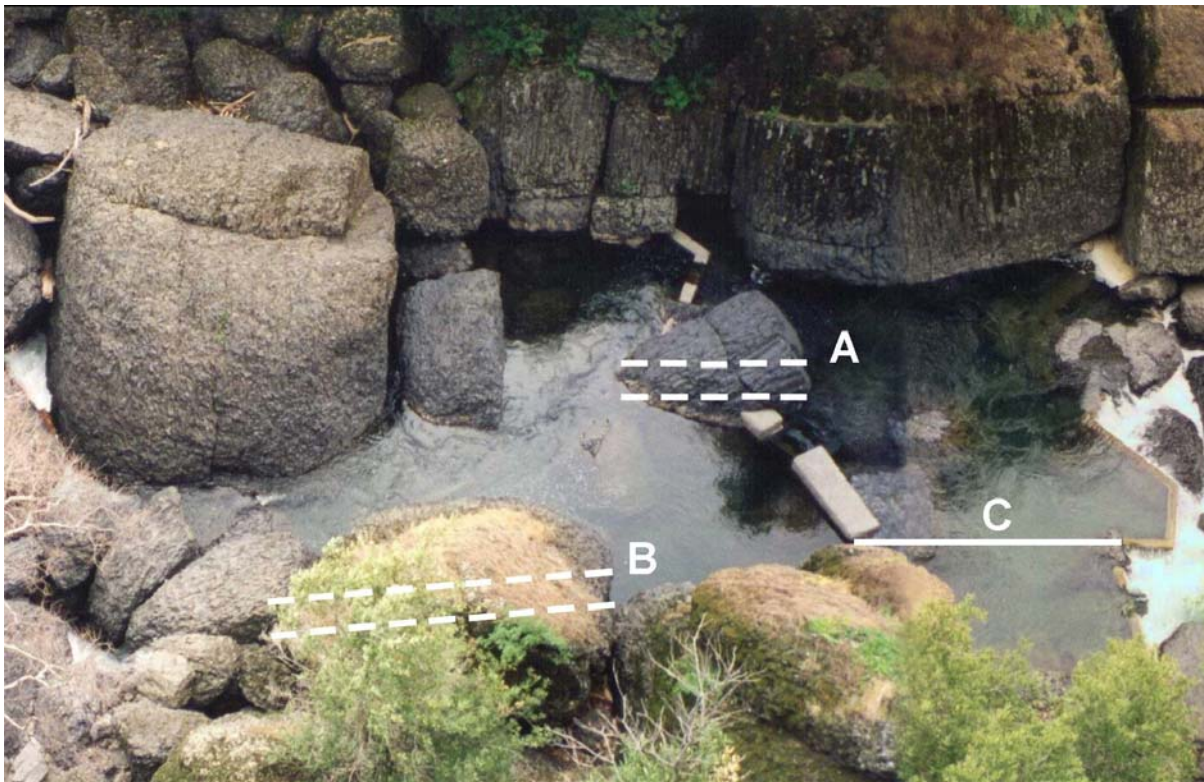
Figure 14. The underwater tunnel has a cross sectional area of approximately 18 square feet and its location is identified by the dashed lines labeled "A" in Figure 14.

Figure 14. Underwater tunnels and new weir location.

It is likely that suitable foundation materials are not far below the surface in the area indicated in Figure 14. This new weir should contain a notch, set at the same elevation as is proposed for Weir 8. If a new weir were constructed, Weir 8 would remain in place and not be altered except to repair leaks on the right bank side if the new weir does not entirely cross Pool 7.

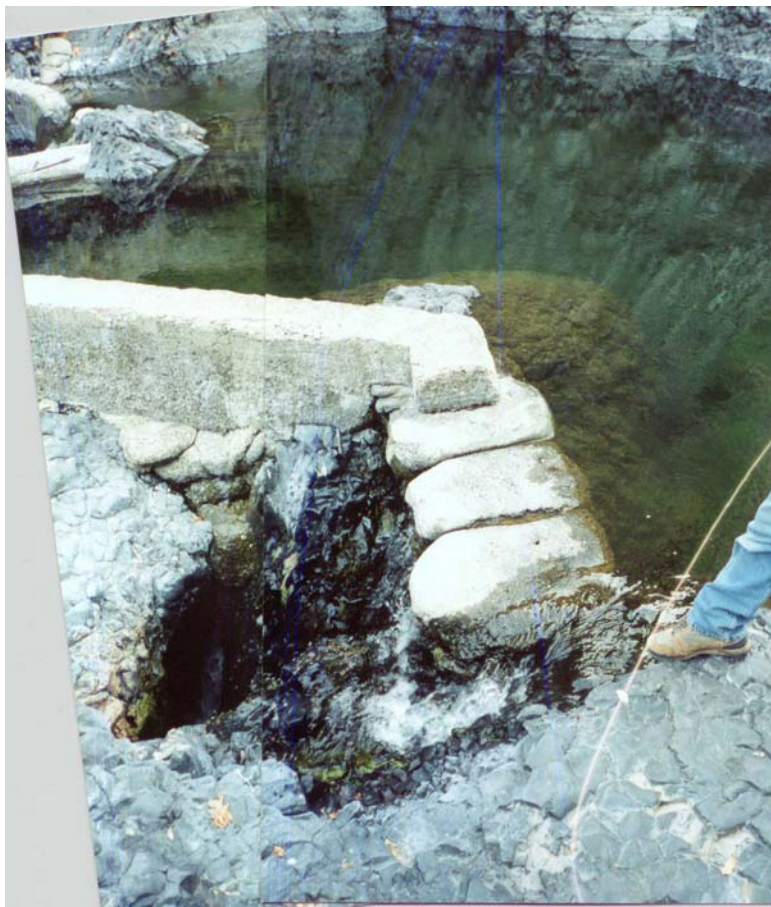
If a new weir in Pool 7 is constructed as proposed, then Weir 7 will need to be rebuilt. The new structure would need to be about 2 feet taller than the existing weir. The reconstruction of Weir 7 should include the repair of leaks that presently exist. One leak is under a rock near the overflow weir shown in Figure 15. Other leaks occur where concrete meets rock, but the most significant leaks occur where concrete sandbags were used in the original construction. Additionally, the existing overflow weir section should be replaced with a new weir so that flow through the lower fish ladder could be more closely regulated. The overflow weir, sandbag construction, and one of the leaks in Weir 7 are shown in Figure 15.

Figure 15. Weir 7 overflow at 24 cfs.

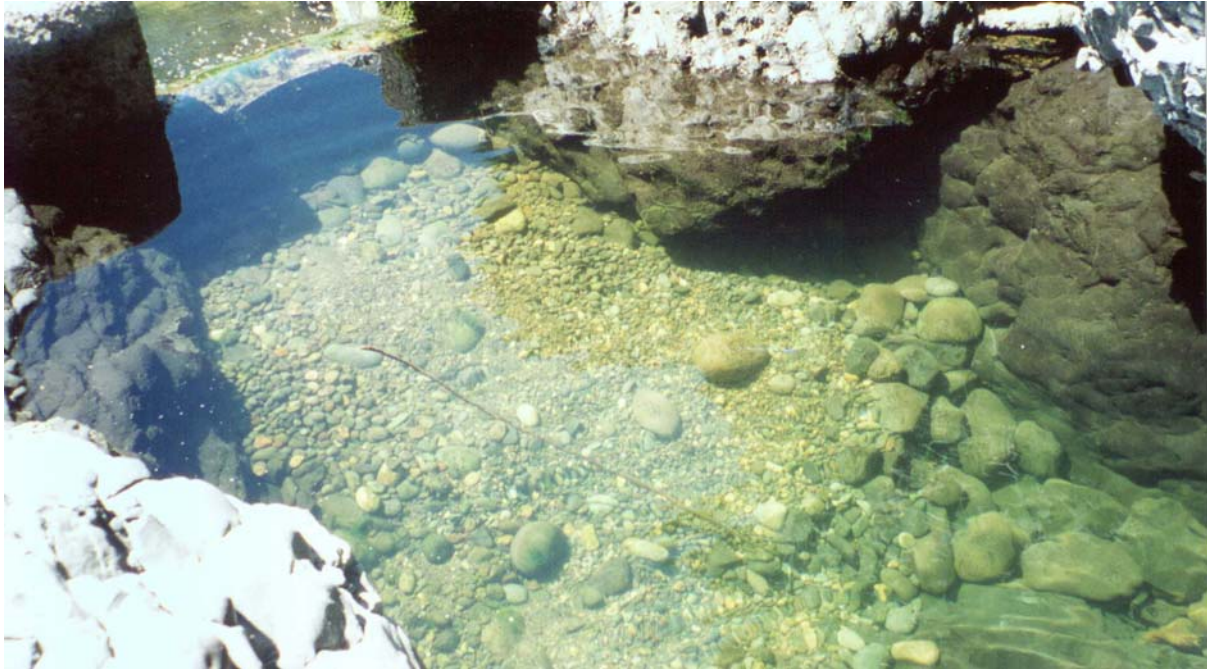
Figure 17. Sediment and cobbles in Pool 5.

To meet this standard, Pools 2, 5, and 6 will need to be deepened. Keeping the pools clean so that they continue to meet the minimum leaping depth requirements will be the responsibility of the fishway operators. Pool depths are based on the assumption that the depth of flow over the downstream weir is 1 foot, or about 10 cfs for a 3-foot-wide weir.

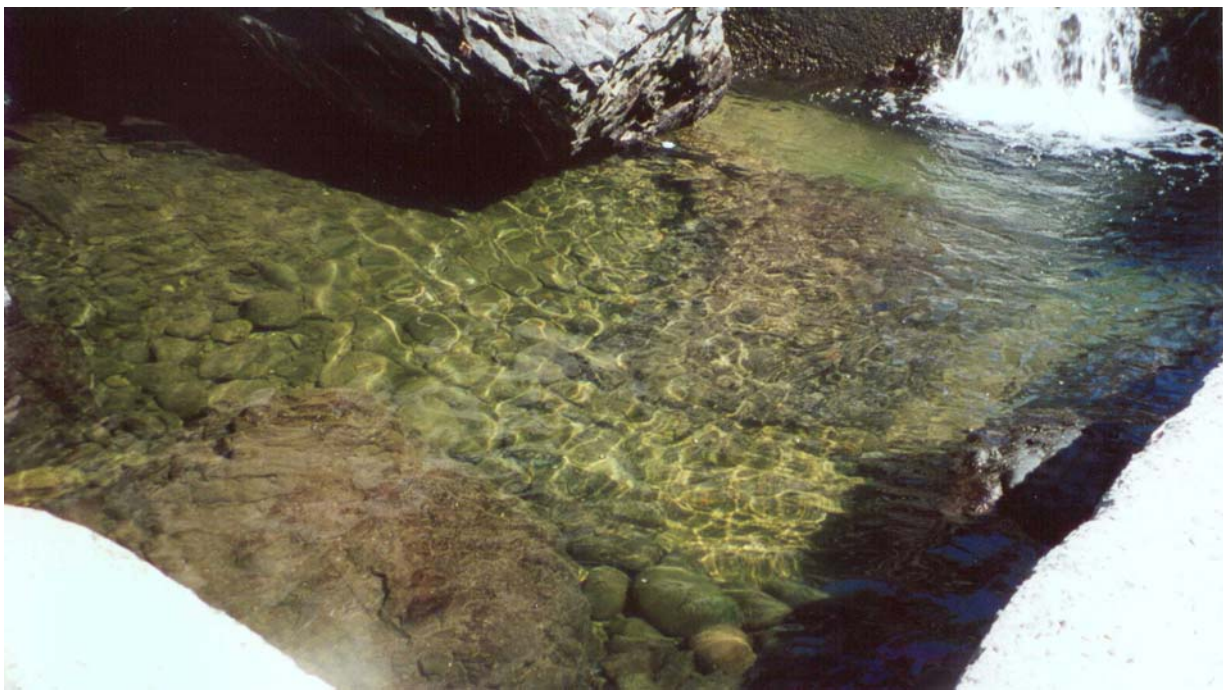
Figure 18. Large rocks in Pool 6.

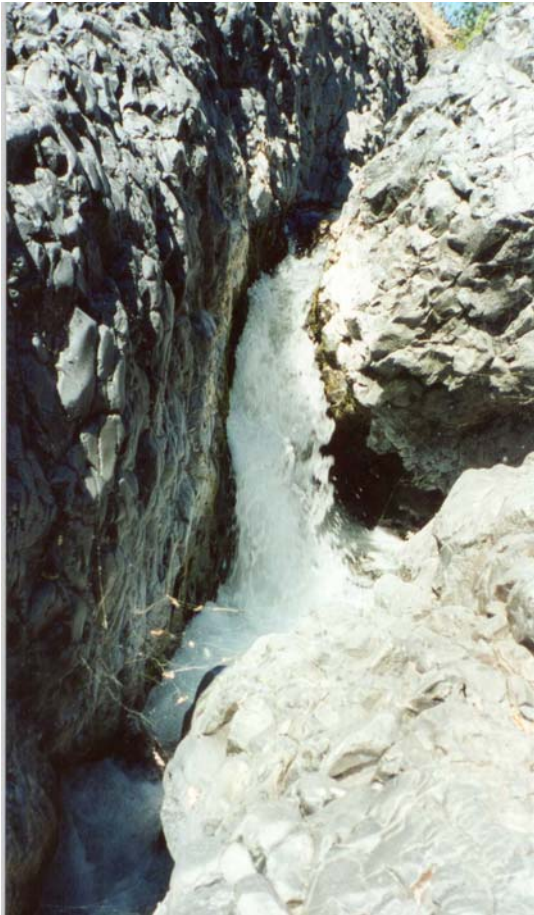
Figure 20. Bear Hole upper constriction area (Looking upstream).

- Excavate the rock at the upper constriction area to open up the passage corridor.
- Consider excavating the lower constriction area that exists immediately downstream.
- Ensure that the creek bed above the modifications is stabilized.

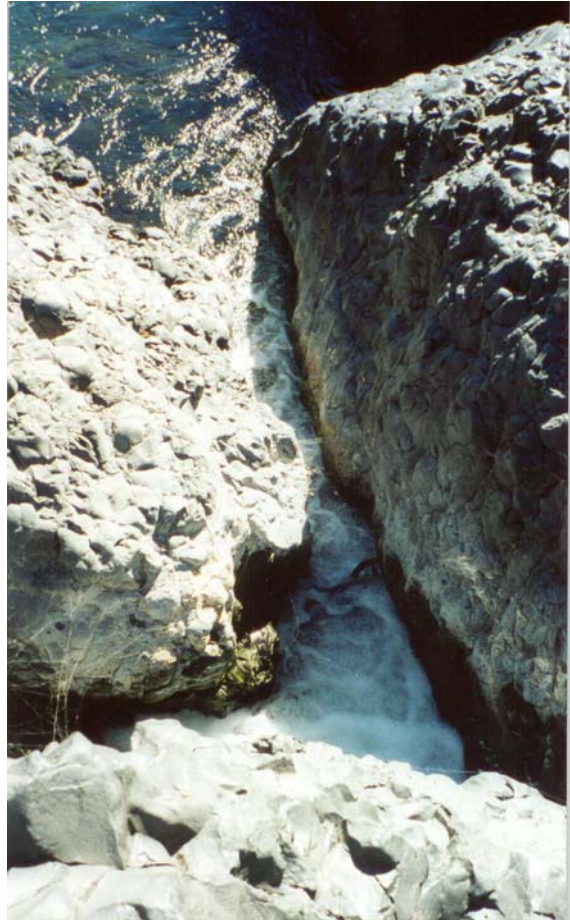
Figure 21. Bear Hole lower constriction area (Looking downstream).
